**NCHRP REPORT 350 UPDATE, TEST 3-11
FULL-SCALE CRASH EVALUATION
OF A MOBILE BARRIER TRAILER,
REPORT REVISION 1**

**SwRI® Test No.
MBT-1**

SwRI® Project No. 18.13922, REV1

**By:
Steve Gomez-Leon, P.E.
Southwest Research Institute®**

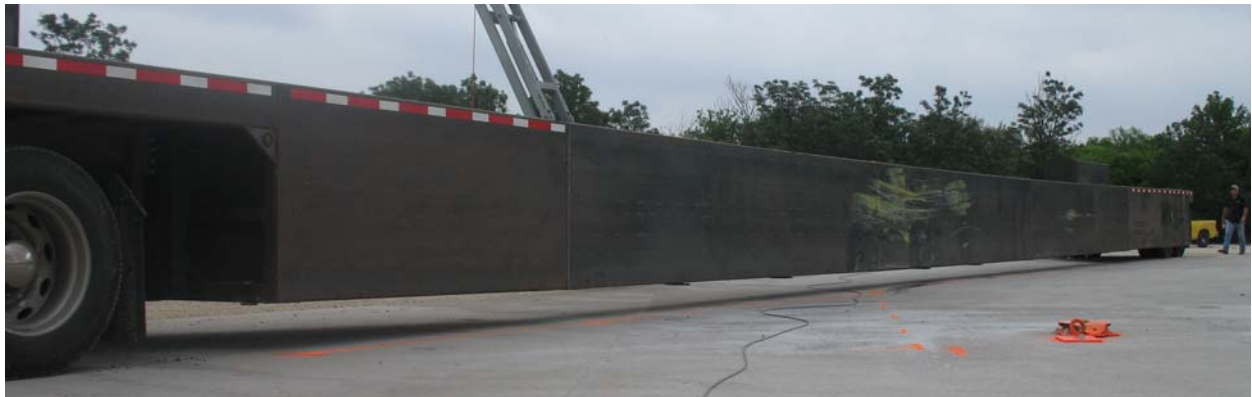
When the test vehicle impacted the Mobile Barrier Trailer, the test vehicle dynamically deflected the barrier 0.61 m (2.0 ft). Figure 3.4 through Figure 3.12 show pictures of the barrier after being impacted by the test vehicle. The mobile barrier trailer experienced minimal damage. Structurally, the barrier did not experience any structural damage. All the steel beams and plates which comprise the Mobile Barrier Trailer were undamaged and none of the welds failed. The only evident structural deformation was of the plates making up the mating surfaces of the wall section joints. The joint plates plastically deformed slightly (as shown in Figure 3.9 to Figure 3.12), but not to a degree that would affect the performance or the assembly of the Mobile Barrier Trailer.

The wall plates on the outer surface of the wall section did not experience any structural damage. The wall plates were not torn, punctured, or gouged. The test vehicle did not snag the wall panels and the vehicle impact did not create any snag points for future vehicle impacts. The only evident damage to the wall plates was aesthetic, where the test vehicle's paint and tires made marks on the barrier. The wheels scratched the barrier, but the wall panels remained smooth. Table 3.2 summarizes the damage sustained by the test article.

Figure 3.4 – Mobile Barrier Trailer after the Crash Test

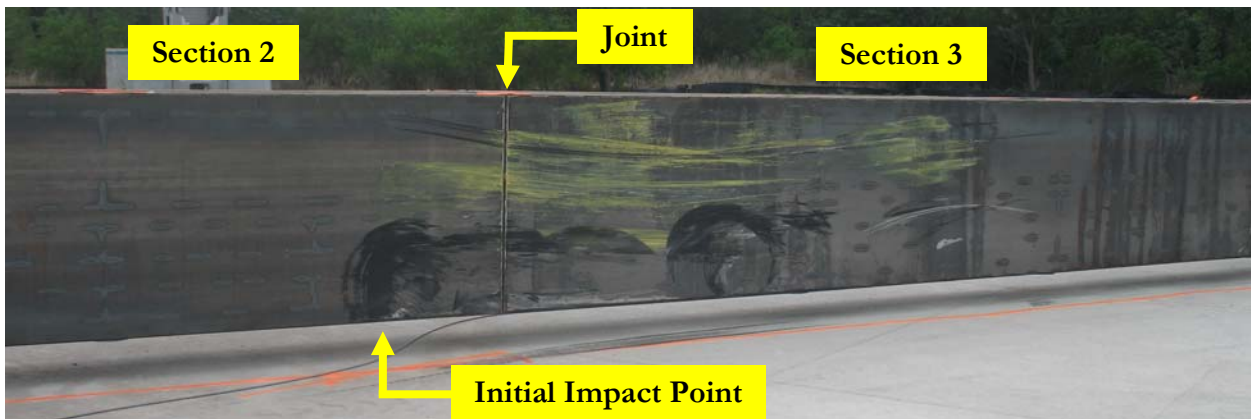
Figure 3.5 – Initial Impact Point of Test Vehicle (At Joint Connecting Sections 2 and 3)

5.1 cm (2 in) measured at middle of section			
	7.6 cm (3 in) measured at downstream end			
2	7.6 cm (3 in) measured at upstream end	NO	YES	<ul style="list-style-type: none"> Point of impact 13 cm (5 in) from downstream end of wall section Cosmetic damage No structural damage

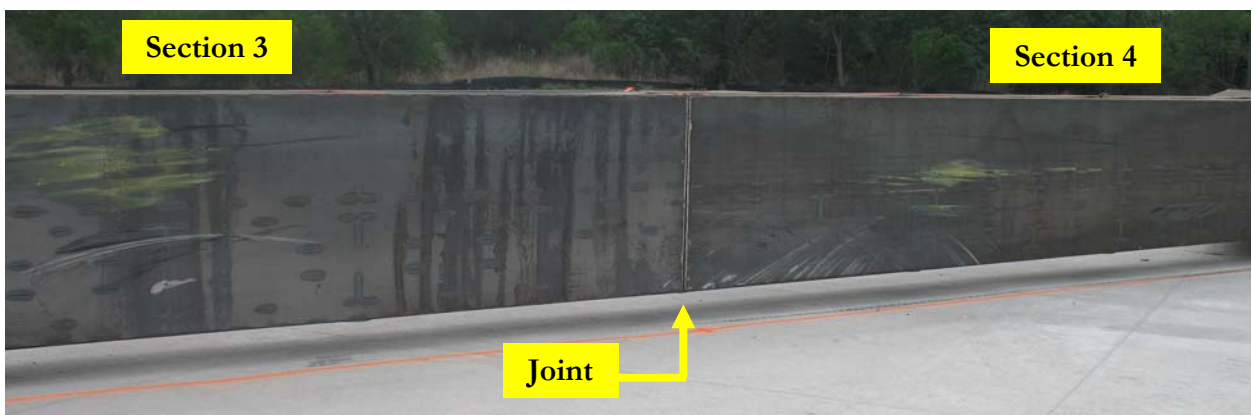
Figure 3.6 – Mobile Barrier Trailer after the Crash Test (Joint Connecting Sections 3 and 4)

8.9 cm (3.5 in) measured at middle of section			
	8.9 cm (3.5 in) measured at downstream end			
3	8.9 cm (3.5 in) measured at upstream end	NO	YES	<ul style="list-style-type: none"> Cosmetic damage No structural damage

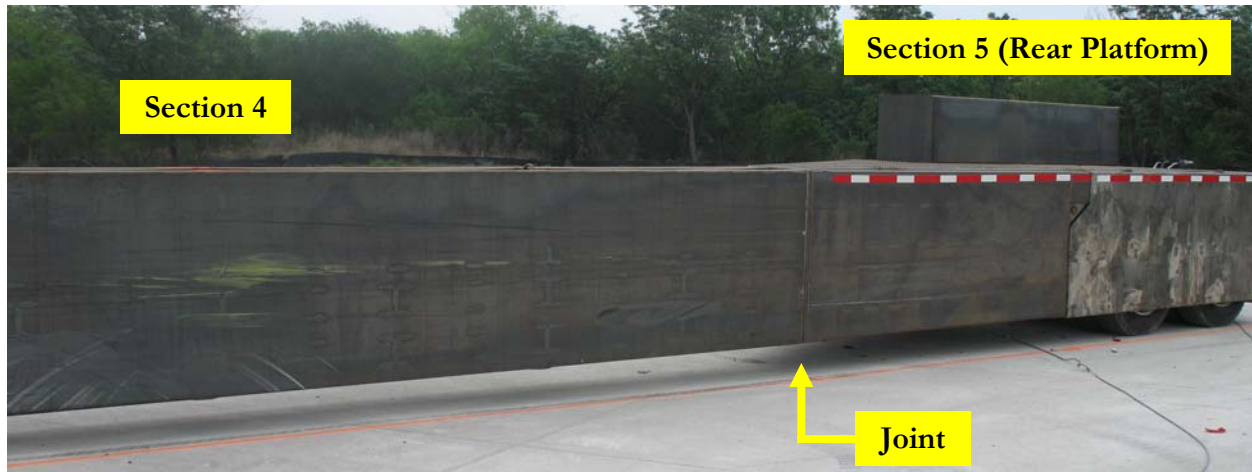
Figure 3.7 –Mobile Barrier Trailer after the Crash Test (Joint Connecting Sections 4 and 5)

9.5 cm (3.8 in) measured at middle of section			
	8.9 cm (3.5 in) measured at downstream end			
4	8.9 cm (3.5 in) measured at upstream end	NO	YES	<ul style="list-style-type: none"> Cosmetic damage No structural damage

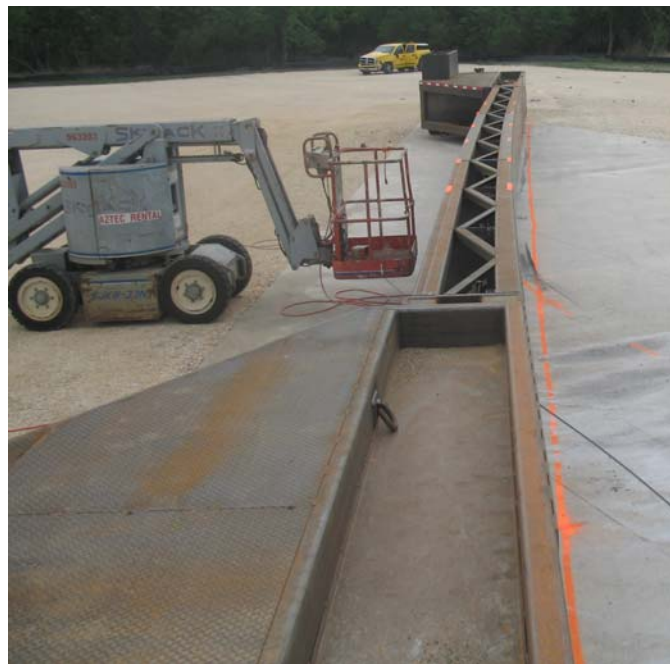
Figure 3.8 – Overhead View of Mobile Barrier Trailer after the Crash Test

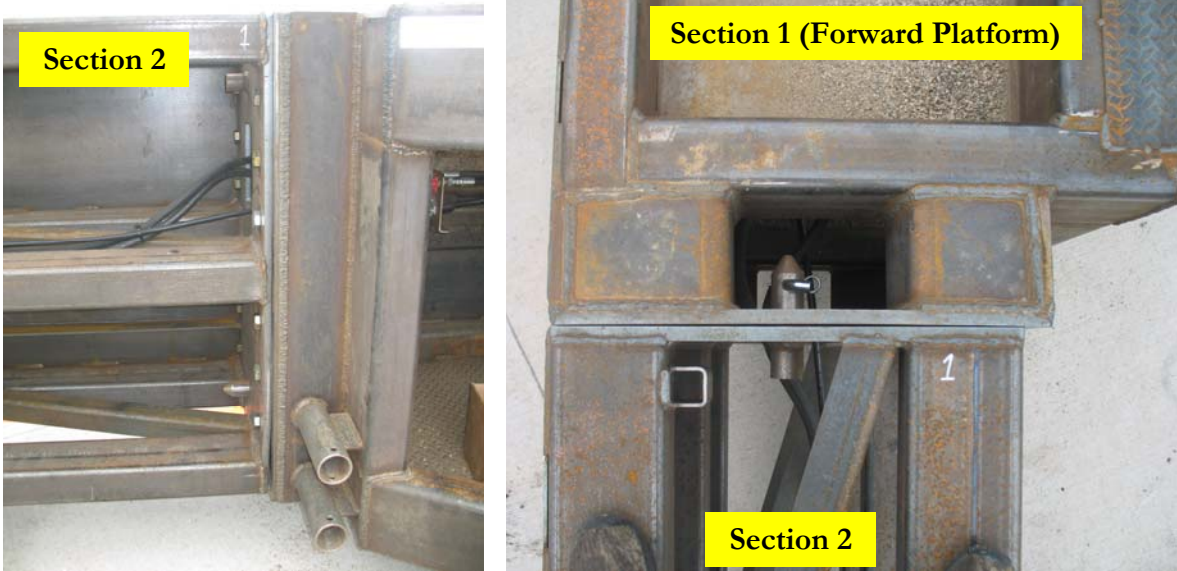
Figure 3.9 – Post Impact Condition of Joint 1 (Connecting Sections 1 and 2)

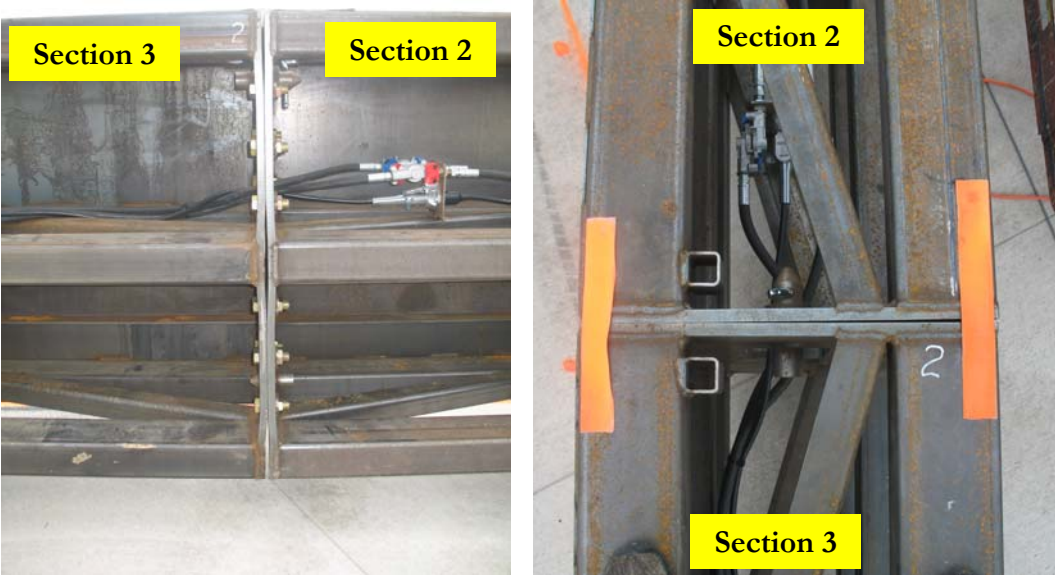
Figure 3.10 – Post Impact Condition of Joint 2 (Connecting Sections 2 and 3)

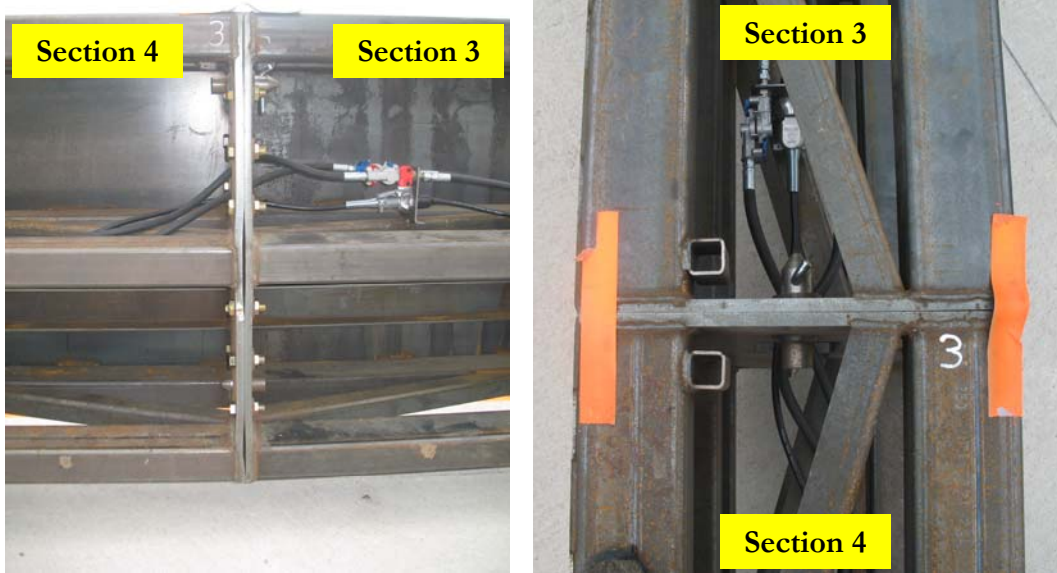
Figure 3.11 – Post Impact Condition of Joint 3 (Connecting Sections 3 and 4)

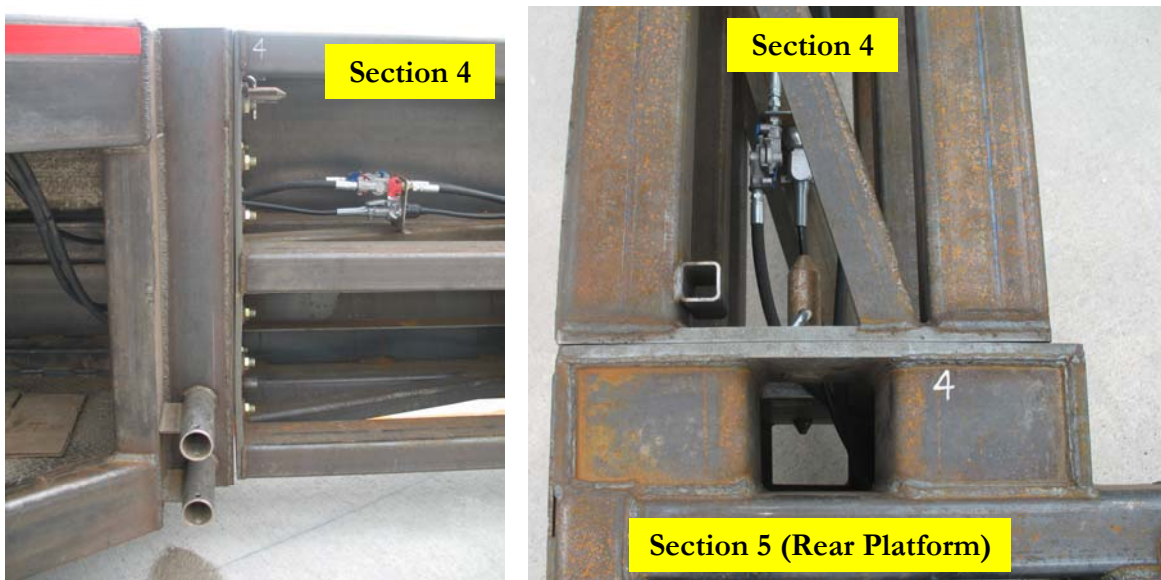
Figure 3.12 – Post Impact Condition of Joint 4 (Connecting Sections 4 and 5)

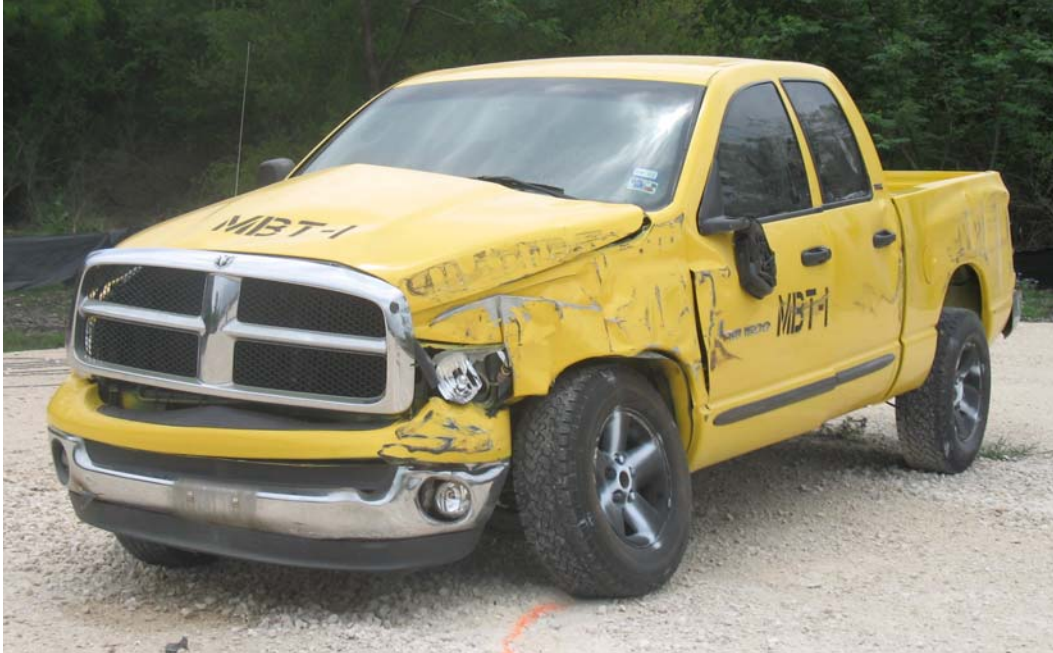
The test vehicle sustained damage to the front bumper, front grill, hood, left headlight trim assembly, left front fender, left front door, left rear door, and left rear fender. The left front A-Frame suspension was damaged and collapsed. All the tires remained inflated. None of the windows cracked or shattered. The vehicle did not sustain any intrusion into the passenger compartment. Due to damage to the vehicle’s left front suspension, the vehicle was not mechanically operable after the test because the collapsed suspension would prevent the front tire from rolling freely or being steered. Photographs of the vehicle damage are shown in Figure 3.13 and Figure 3.14.

Figure 3.13 – Damaged Test Vehicle (Left Side)

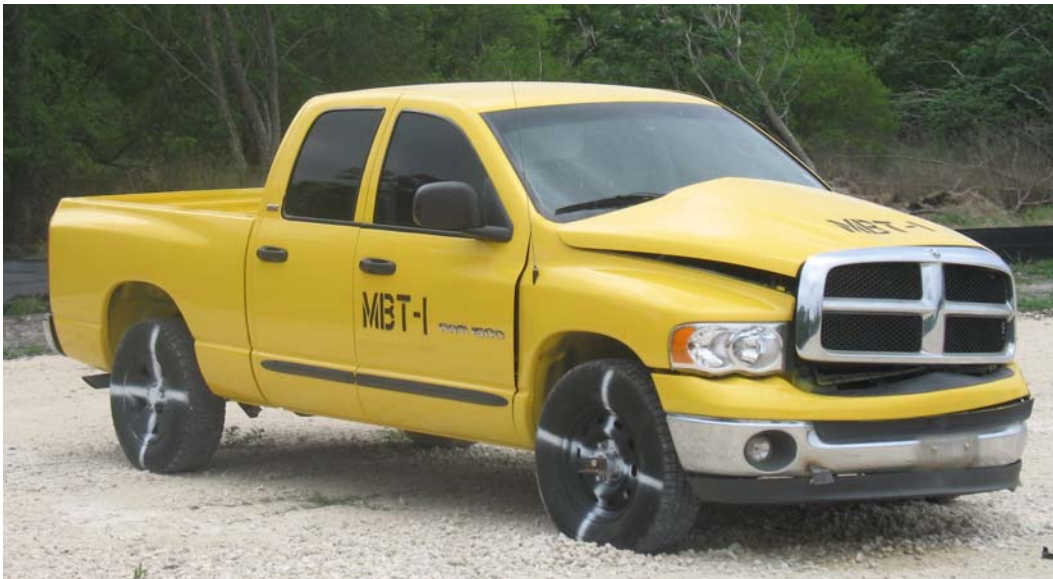
Figure 3.14 – Damaged Test Vehicle (Right Side)
